Sujet : Faisceau volant (904601998B)

Subject : Steering wheel loom (904601998B)

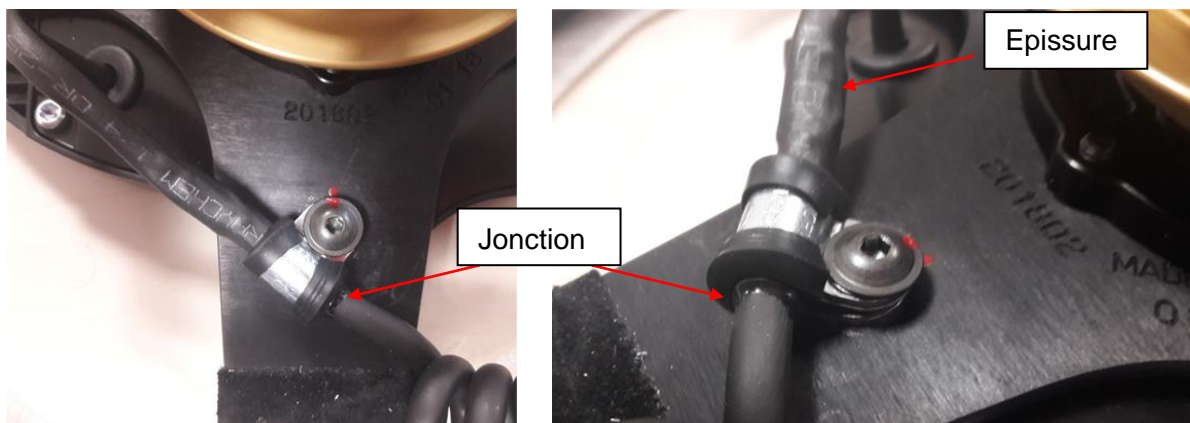
Afin de fiabiliser le fonctionnement de la platine volant (pour éviter des coupures de fils), merci de contrôler les points suivants :

- le faisceau est tenu par la jonction entre les 2 parties du faisceau et non sur ou juste à raz de l'épissure (repérable grâce à la surépaisseur du faisceau) pour éviter de cisailier le faisceau à cet endroit,
- veillez également à ce qu'il ne vienne pas entre le volant et le quick en orientant l'agrafe comme sur la photo,
- la protection de l'agrafe doit être correctement placée pour éviter de blesser le faisceau lors du serrage de l'agrafe,

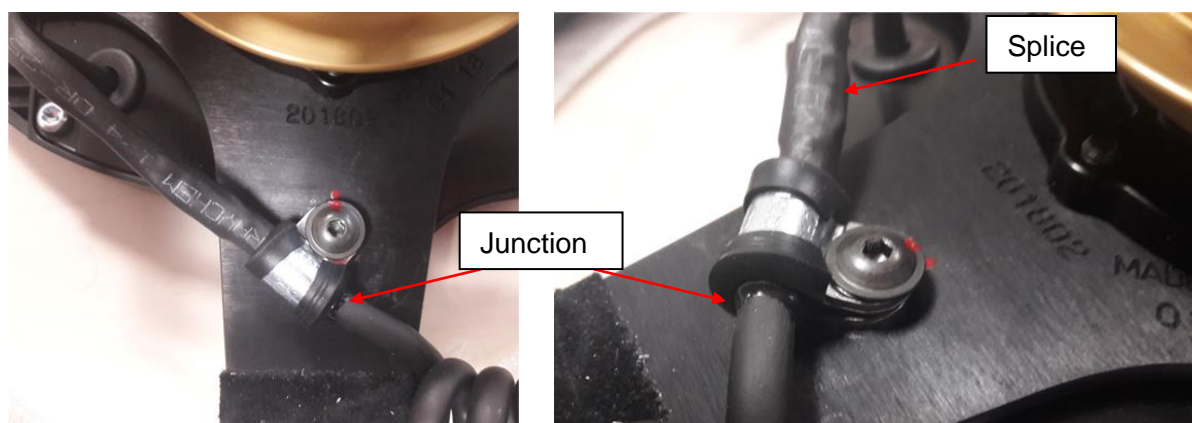
In order to improve the reliability of steering wheel panel (to avoid wire cut), please check the following points:

- the steering wheel panel loom is held by the junction of the 2 parts of the loom and not by the splice or just close to the splice (can be seen by the thicker part of the loom) to avoid to shear the loom,
- the loom does not interfere with the quick release by directing the staple clip as on the picture below,
- the staple protection is well placed to not damage the loom during tightening,
