## **Subject : Dashboard**

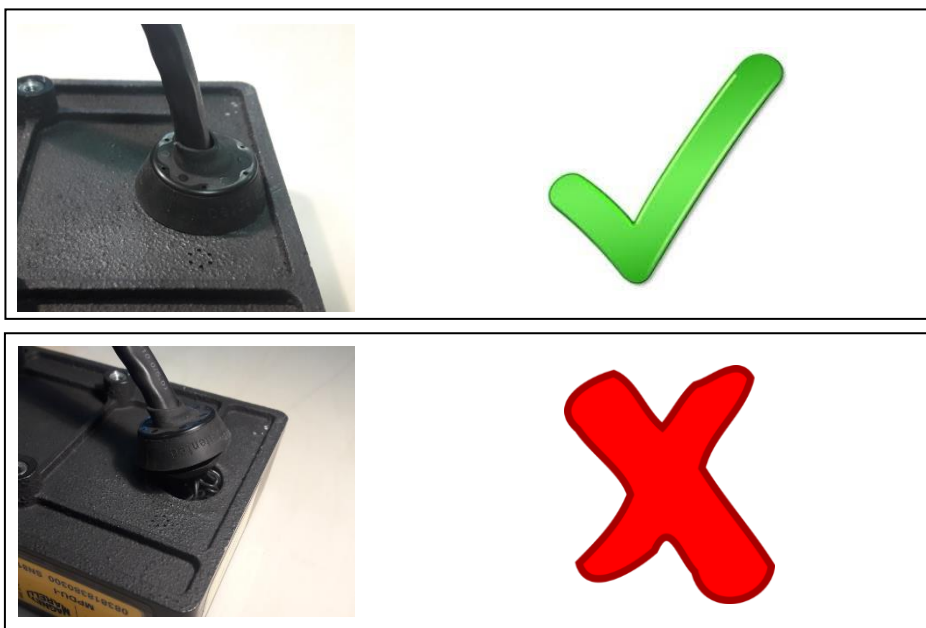
To ensure a correct operation of the dashboard (ref 3S1C21719B), please check the grommet is well in place at the back of the unit. In case of a bad position, wires can scratch to the edge of the housing and eventually cause a malfunction.
